New York State Department of Transportation

Yellow Flag NB2258W021

BIN: 1065318

Feature Carried: 278I278IX2M23027

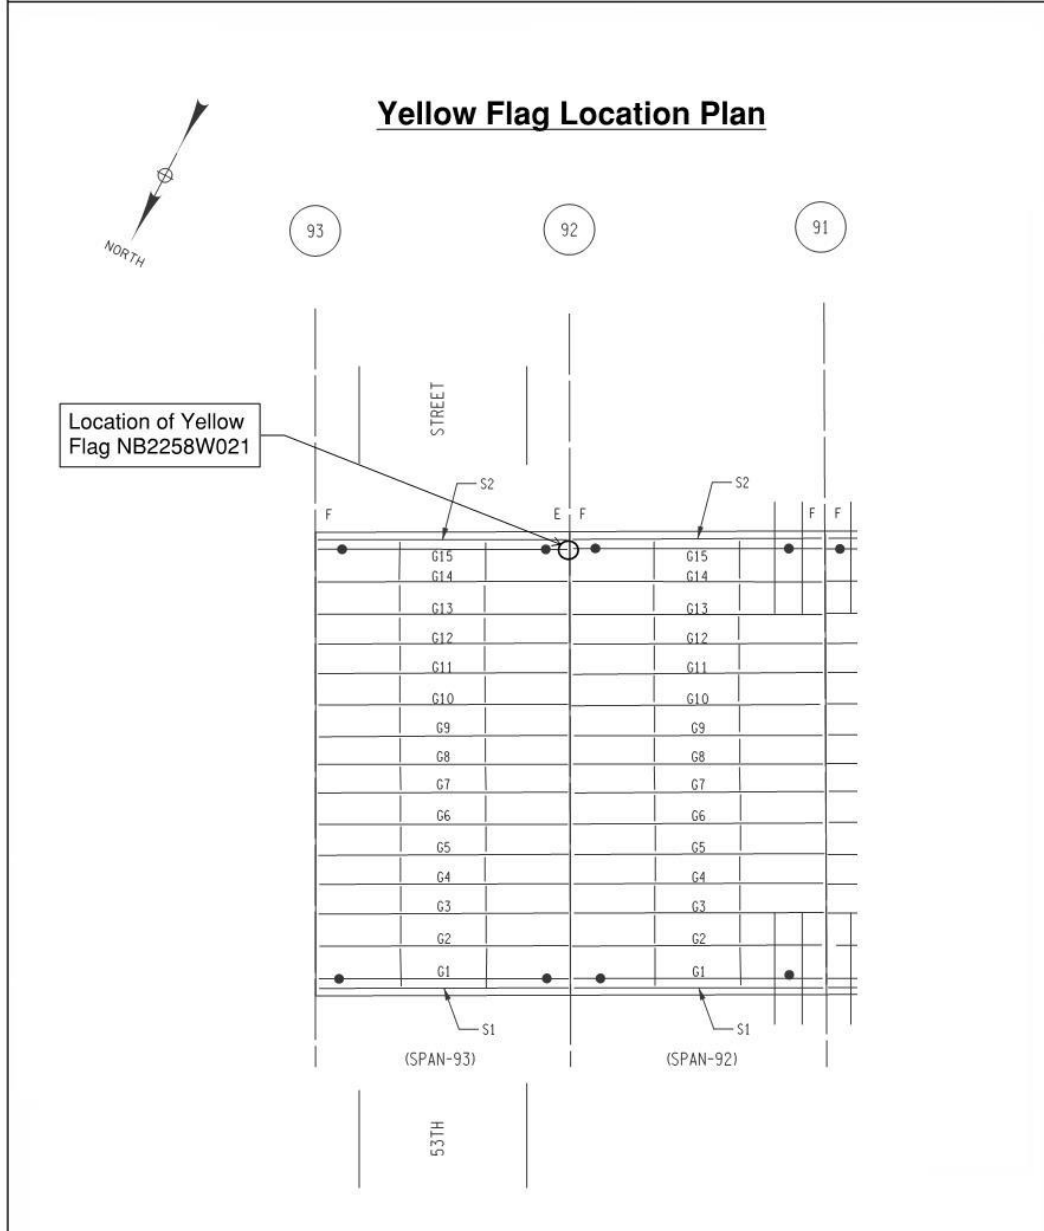
Flag PhotographsPhoto Number: **1**Photo Filename: **22_Flag Location Plan.jpg**Gowanus Expressway
2022 Biennial Inspection - Field SketchBIN: 1065318Team: AA/TSDate: 10/20/2022Span: 93Location: Bearing at G15 at Pier 92

Location: Bearing under Girder G15 on Span 93 side of Pier 92 located within scaffolding platforms installed by contractor (area located above intersection of 53rd Street and 3rd Avenue).

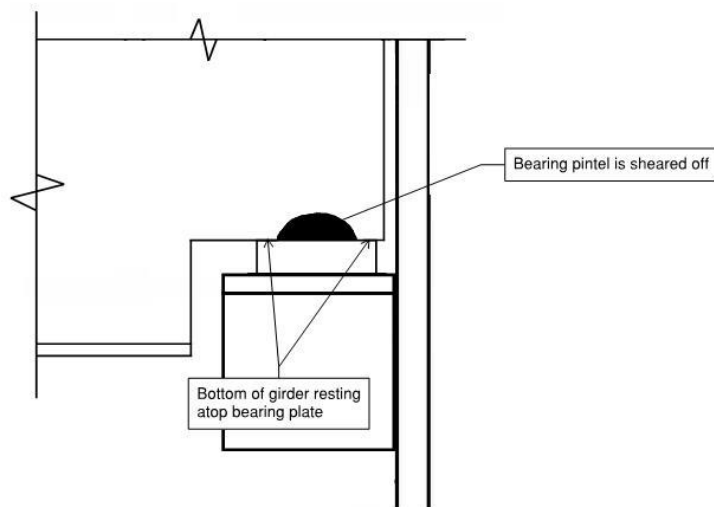
Photo Number: 2

The bearing under Girder G15 on Span 93 Side at Pier 92 exhibits a sheared off pintel resulting in the girder end resting atop the bearing plate (Photo 5). Due to the sheared off pintel, the end of the girder has shifted downwards slightly which is evident by both guide angles breaking into two pieces at each face with 1" high difference between the guide angles pieces at each face (Photos 6 and 7). There are no additional signs of distress at the end of the girder due to the slight downwards shift. The bearing plate is loose when inspection team hammers but remains in place. The pedestal under the girder exhibits up to 15% section loss for the full height of two out of three stiffener plates (left and right stiffeners) (Photo 8). (refer to Yellow Flag Condition Sketch Photo #2 for more details)

**Left Face of Bearing B15**SCALE: N.T.S.**Notes:**

- The right face of the bearing has similar condition.
- The guide angle at the bearing not shown for clarity purposes.
- The bearing plate is loose but remains in place due to keeper plates.

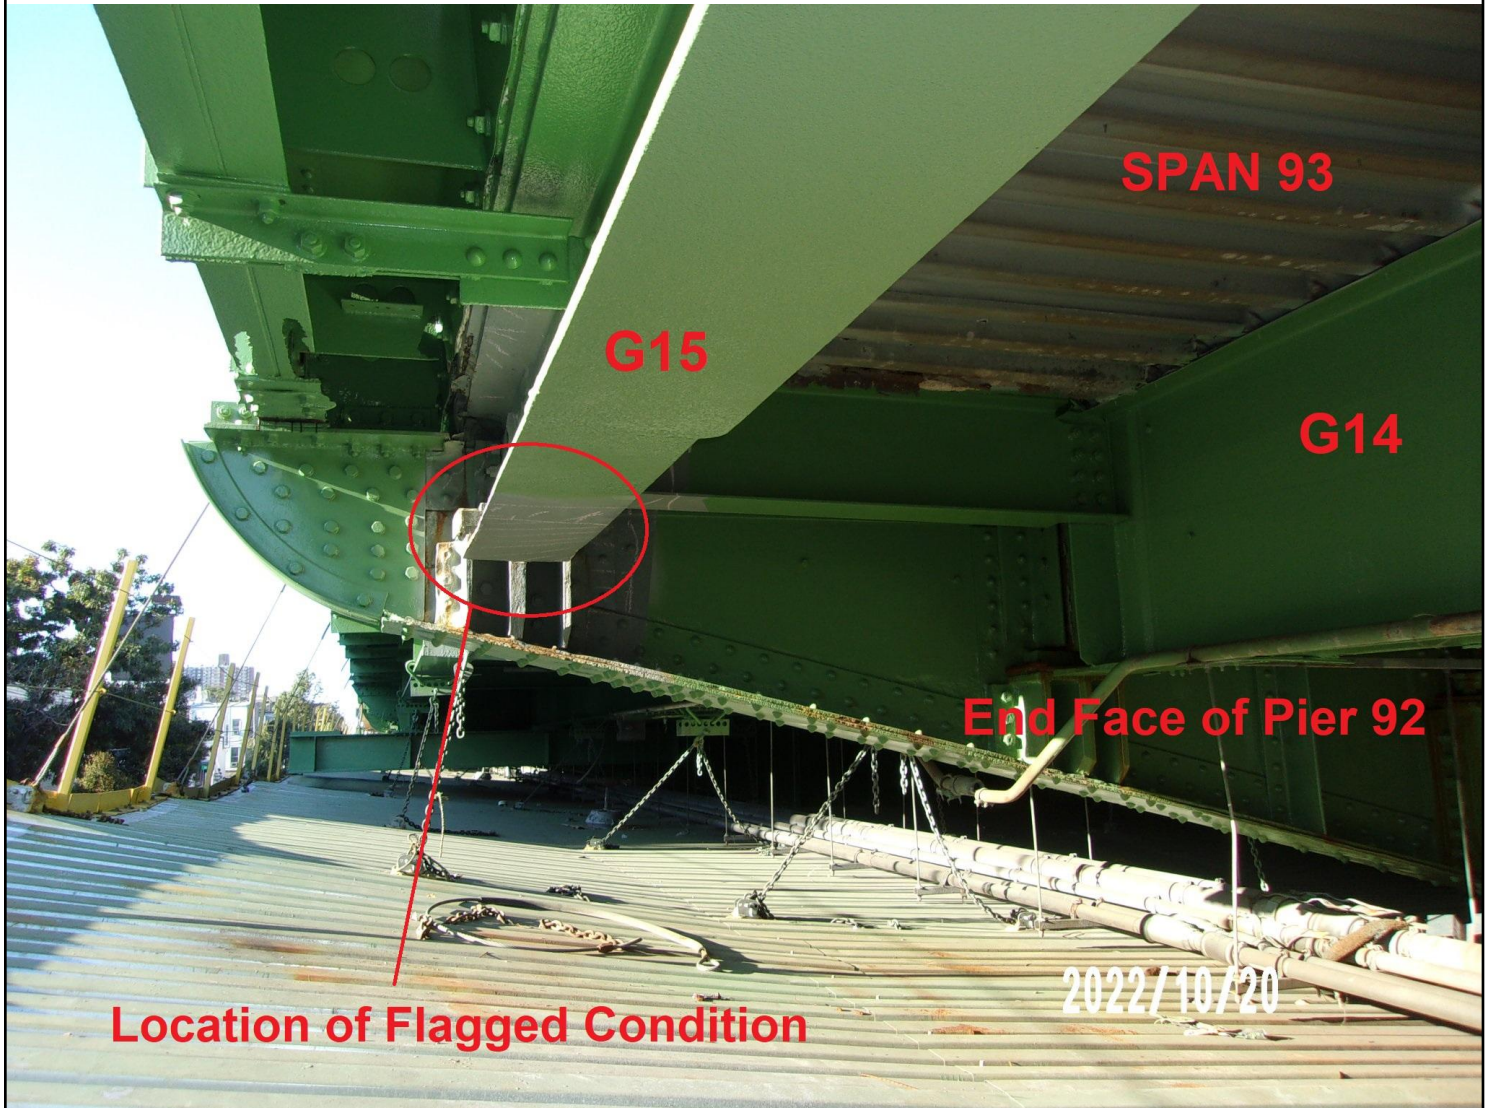
Photo Number: 3

Attachment Description: General view of the flagged condition at the bearing under Girder G15 on Span 93 side of Pier 92. Looking Begin.

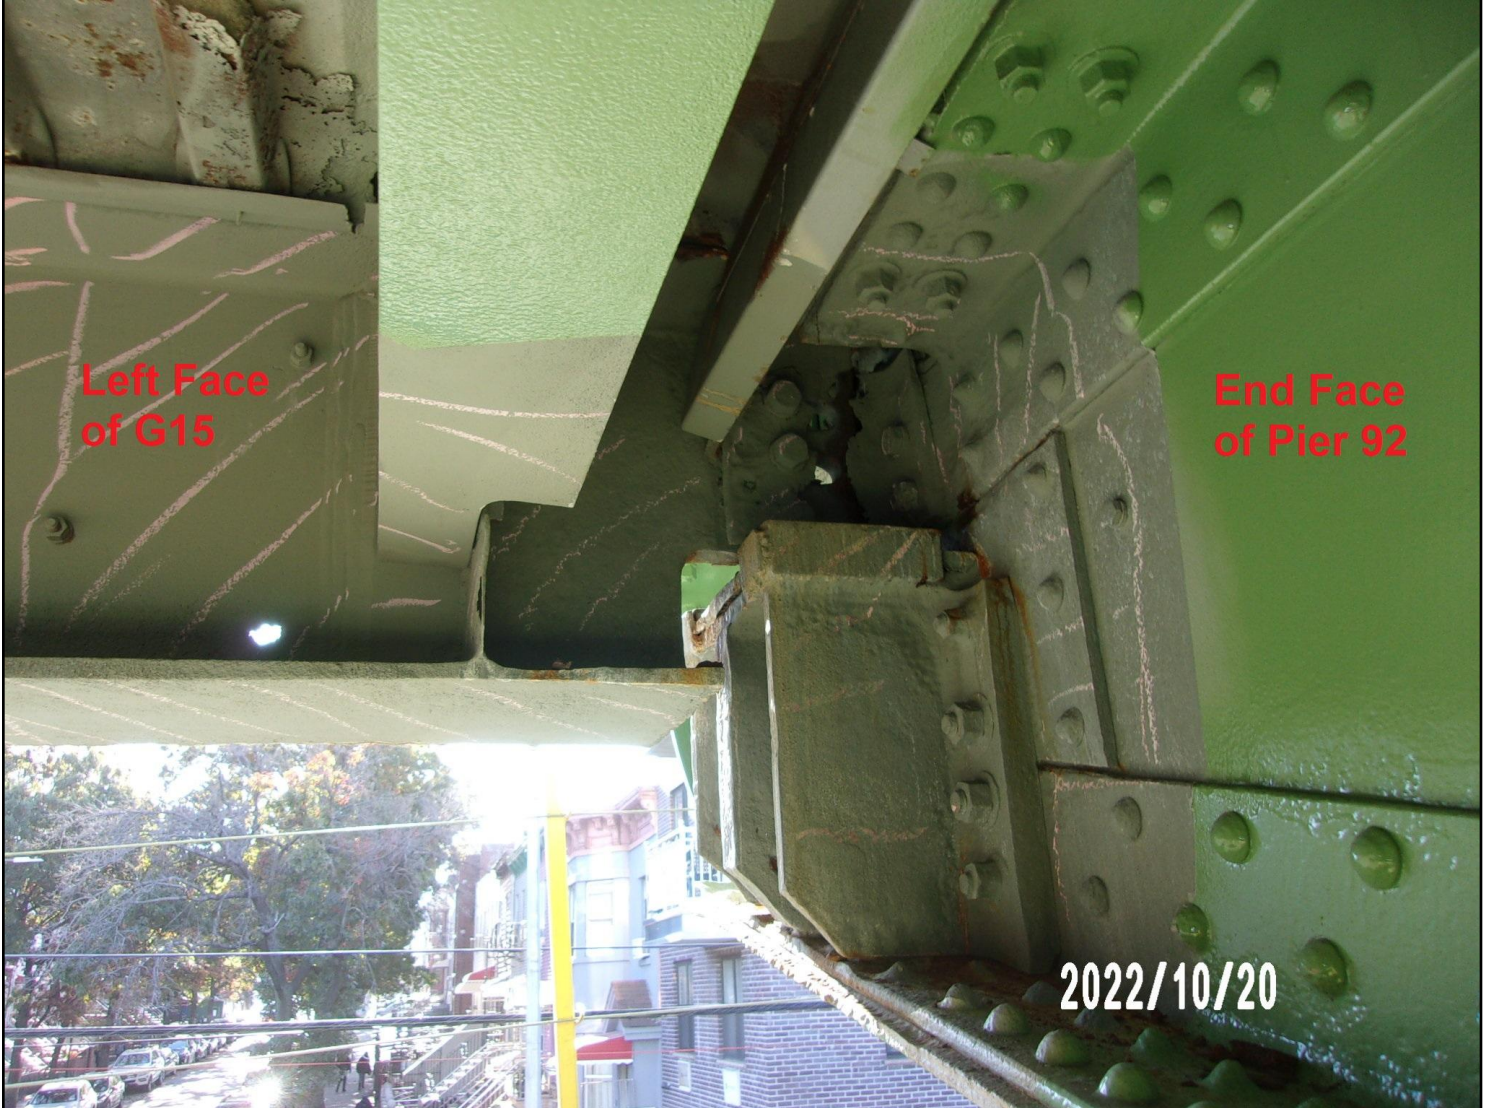
Photo Number: 4

Attachment Description: Close-up general view of the bearing under Girder G15 on Span 93 side of Pier 92. Looking Begin and Right.

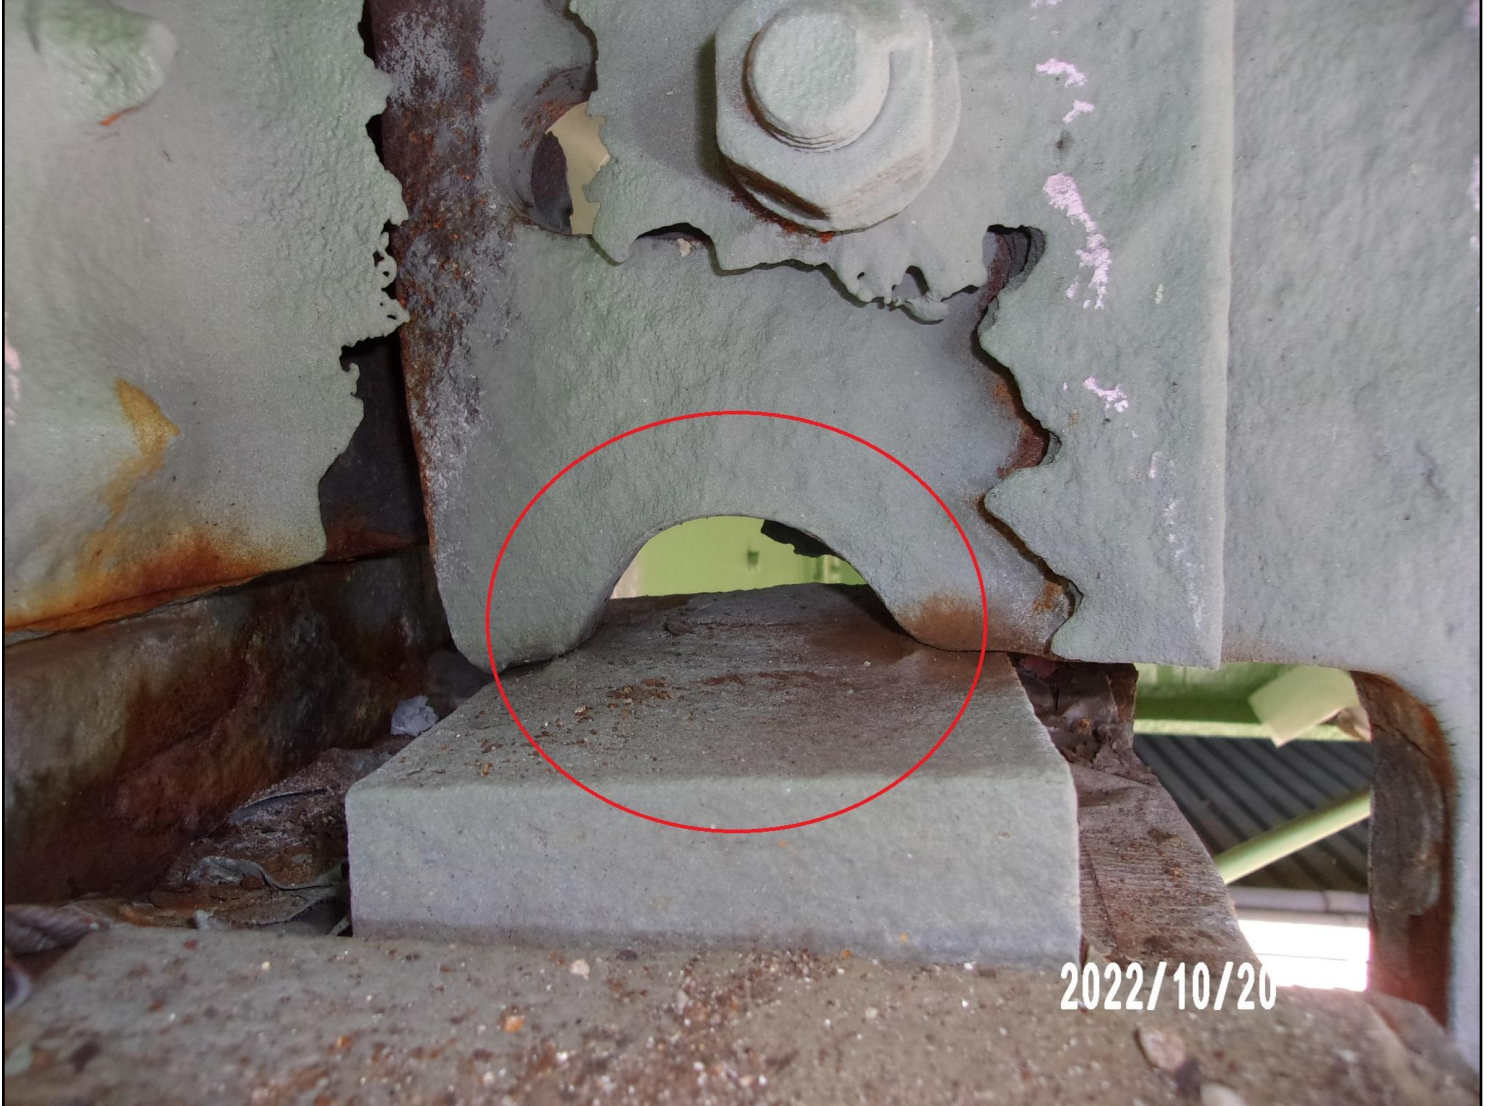
Photo Number: 5

Attachment Description: The right face of the bearing under Girder G15 on Span 93 side of Pier 92. The bearing exhibits a sheared off pintel resulting in the end of the girder resting atop the bearing plate. The bearing plate is loose when inspection team hammers but remains in place. Looking Left.

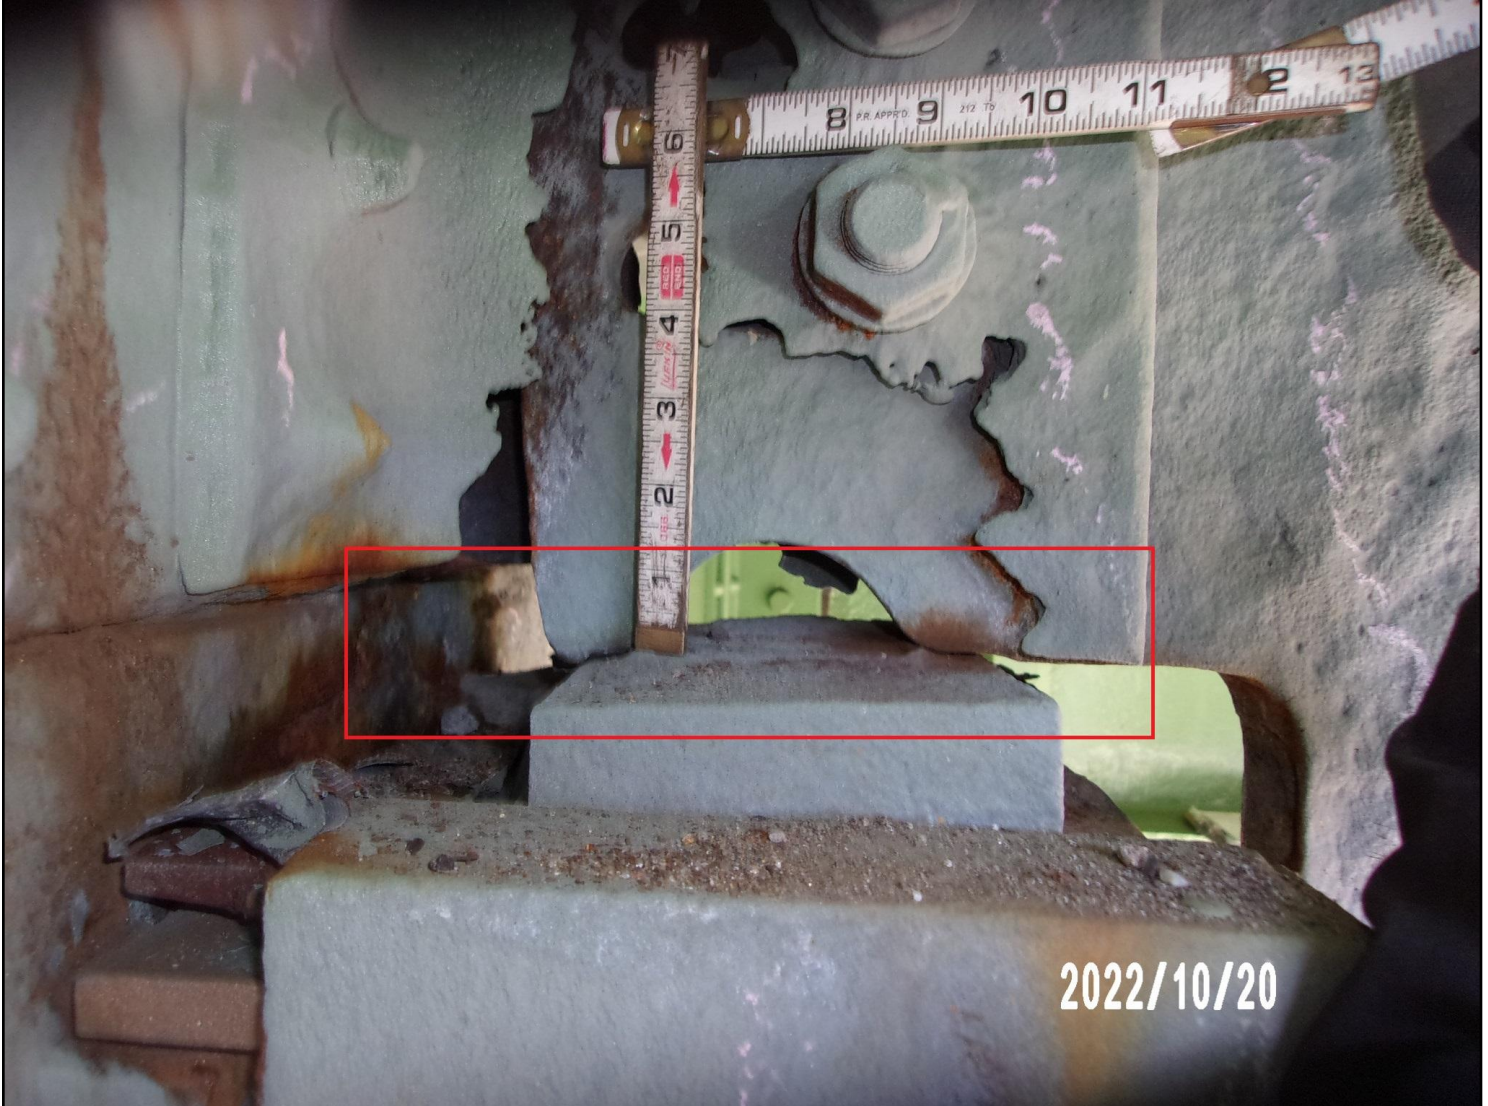
Photo Number: 6

Attachment Description: The right face of the bearing under Girder G15 on Span 93 side of Pier 92. The end of the girder has shifted downwards slightly which is evident by guide angle breaking into two pieces at the face of the girder with 1" high difference between the guide angle pieces. Looking Left.

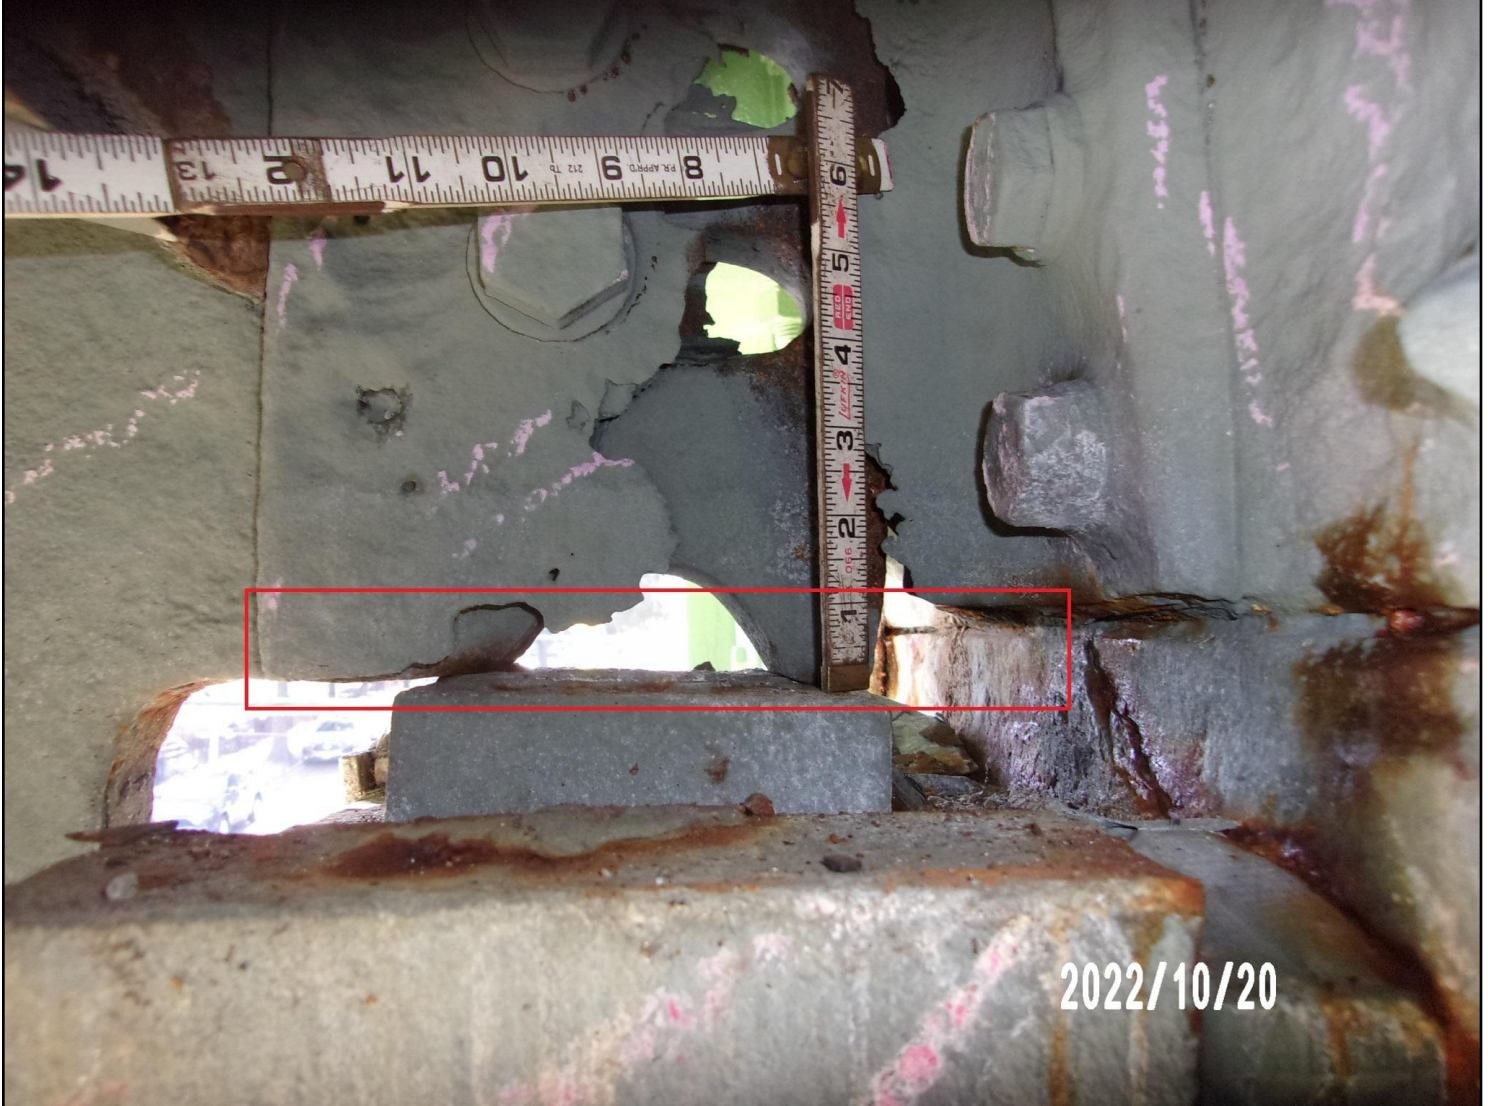
Photo Number: 7

Attachment Description: The left face of the bearing under Girder G15 on Span 93 side of Pier 92. The end of the girder has shifted downwards slightly which is evident by guide angle breaking into two pieces at the face of the girder with 1" high difference between the guide angle pieces. Looking Right.

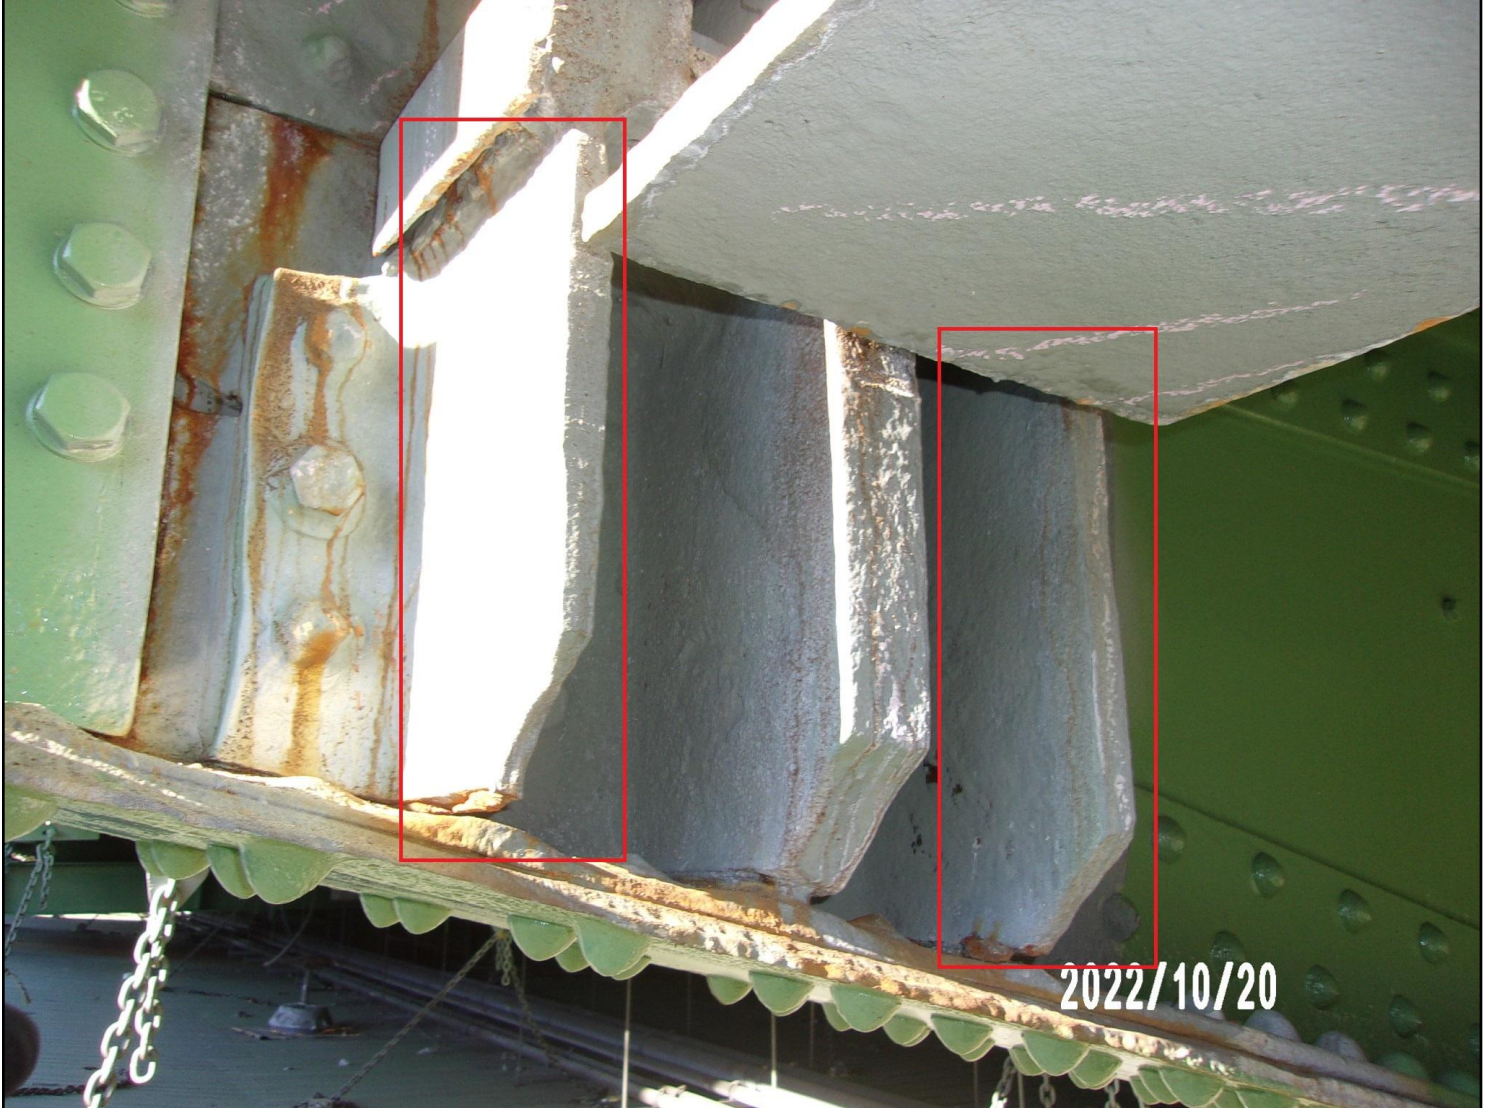
Photo Number: 8

Attachment Description: The pedestal below the bearing under Girder G15 on Span 93 side of Pier 92. Two out of three stiffener plates exhibits up to 15% section loss for the full height of the stiffeners. Looking Begin and Right.

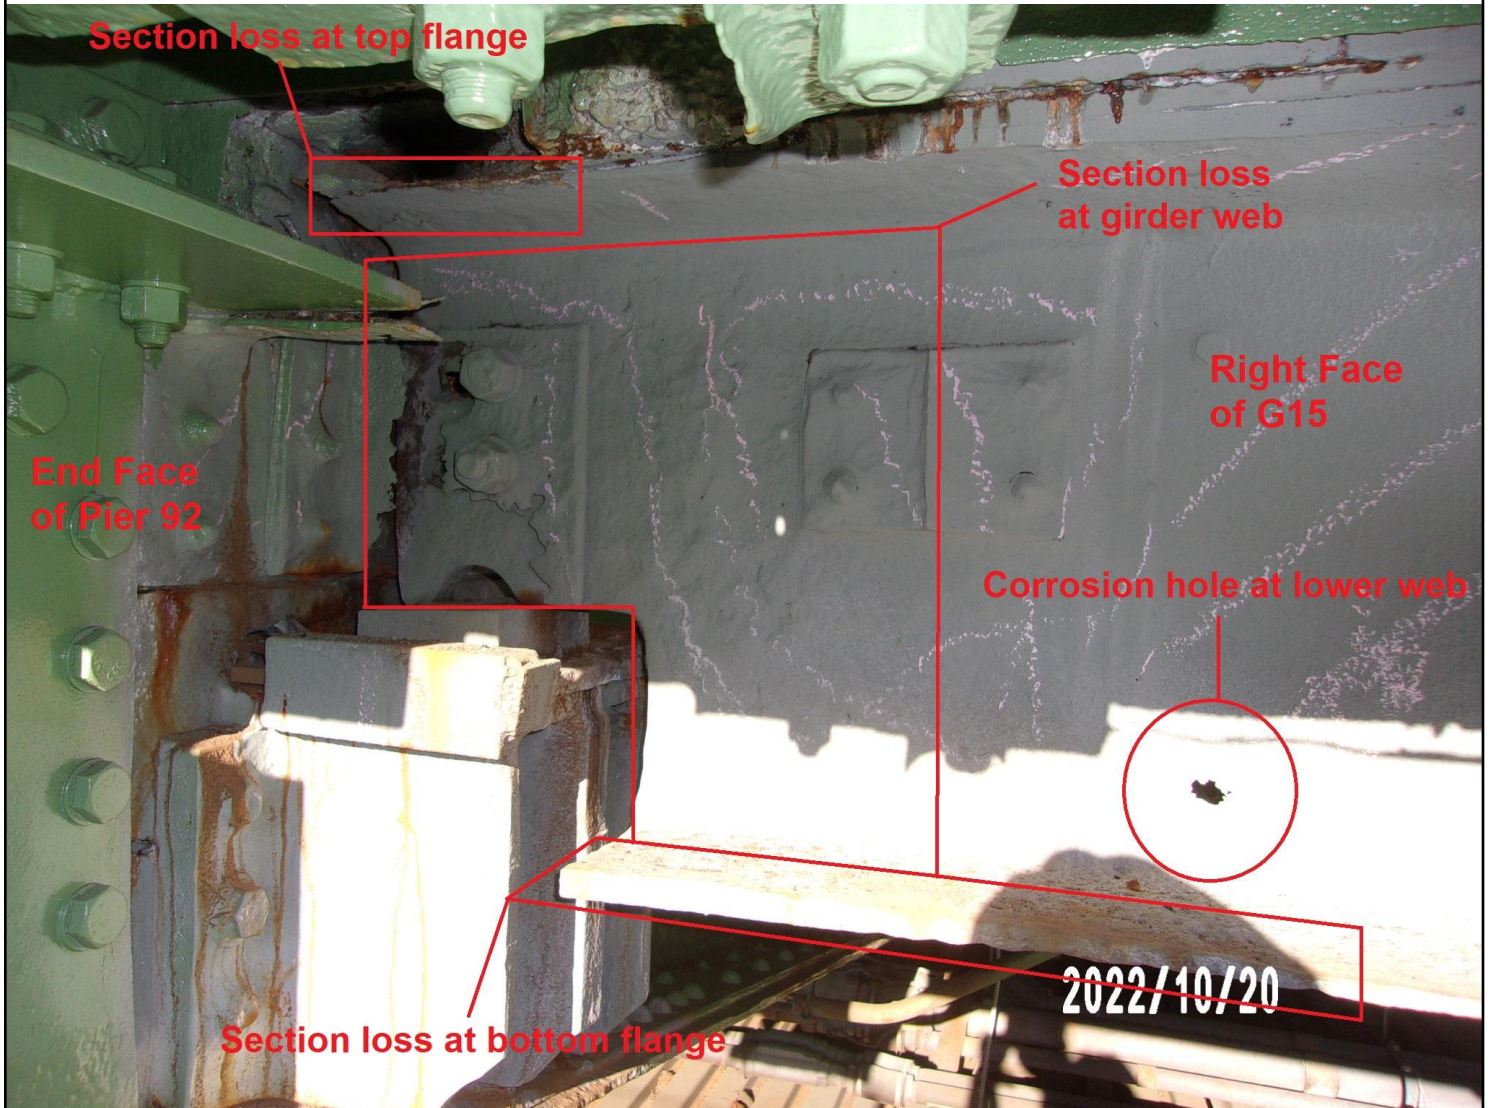
Photo Number: 9

1. The girder end above the bearing exhibits section loss for the full height of the web along the guide angle for 12" wide for up to 1/8" deep at the left face and up to 3/16" deep at the right face. The lower web of the girder exhibits 1" diameter corrosion hole approximately 2" from the bottom flange located 19" from the end side of the bearing with 30% section loss surrounding the hole for 1" wide. The bottom flange exhibits up to 25% section loss for the full width of the flange for 24"L. The right side top flange exhibits 50% section loss for 10"L x 4"W at the end of the girder. The left end diaphragm connection plate exhibits up to 50% section loss with 3"H x 2"W corrosion hole at the bottom 5" of the plate. (Photo 9)

Attachment Description: The right face of Girder G15 on Span 93 side of Pier 92. The girder exhibits up to 3/16" section loss for the full web height along the guide angle with 50% section loss at the top flange and up to 25% section loss at the bottom flange. Also, the lower girder web exhibits 1" diameter corrosion hole with 30% section loss surrounding hole. Looking Left.
